Silicon Precipitate Nodule-Induced Failures of MOSFETs

M. Johnson and D. Pote
Motorola, Inc.
Northbrook, IL

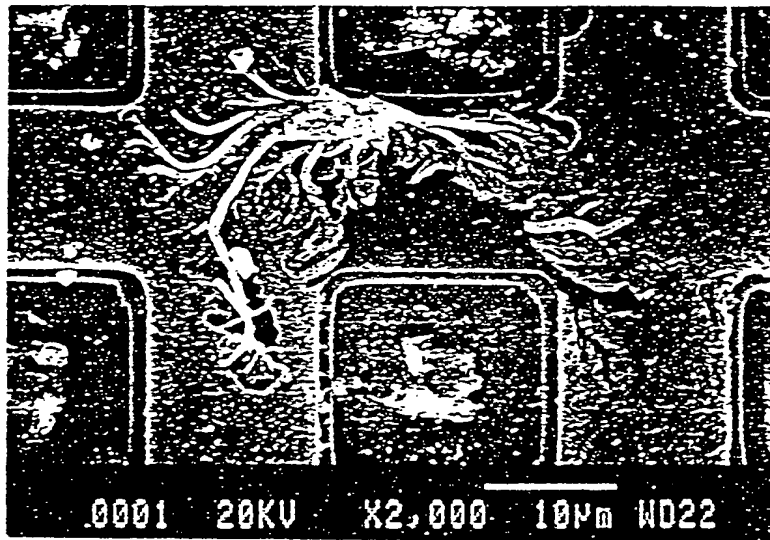
Figure 1: Unique pattern of fused polysilicon observed after removal of metallization and insulating oxide. (2000X)

Subsequent optical inspection identified an apparent electrical damage site under the wirebond. This damage was characterized by a central fused-site surrounded by multiple filaments (Figure 1). These filaments were dubbed "tentacles" or "roadkill" damage because of their appearance. SEM inspection of the same locations revealed surprisingly little

It is now believed that the filaments are the result of amplification of the damage at the original failure sites by the application of excess power during liquid crystal testing. A slightly higher level of power was necessary to counteract the obstructing heatsink effect of the relatively large wirebond. The heat generated at the damage site would initiate crystallization of the amorphous polysilicon depend-

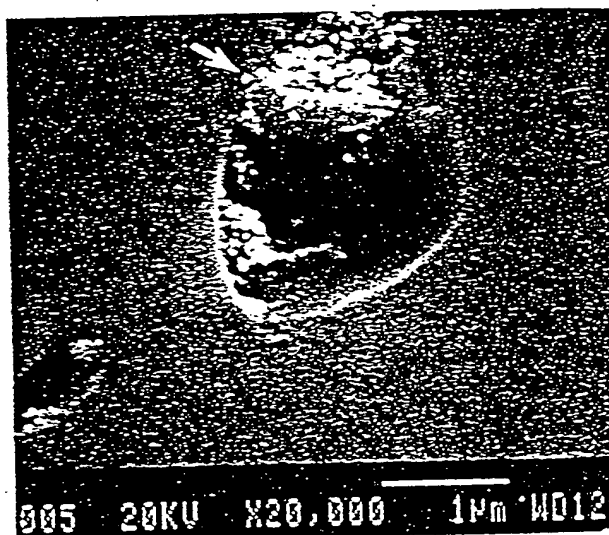
Figure 2: Small electrical damage site within chiplet. (25000X)

Cross-sections of failures revealed that the filaments were confined to the polysilicon layer, except at the central nucleus. At the nucleus, melted silicon and aluminum were observed extending vertically through the dielectric layer. On several devices where the filamentation was minimal, there was limited evidence of melting at the nucleus site and a small section or chip of the dielectric was missing (figure 2).

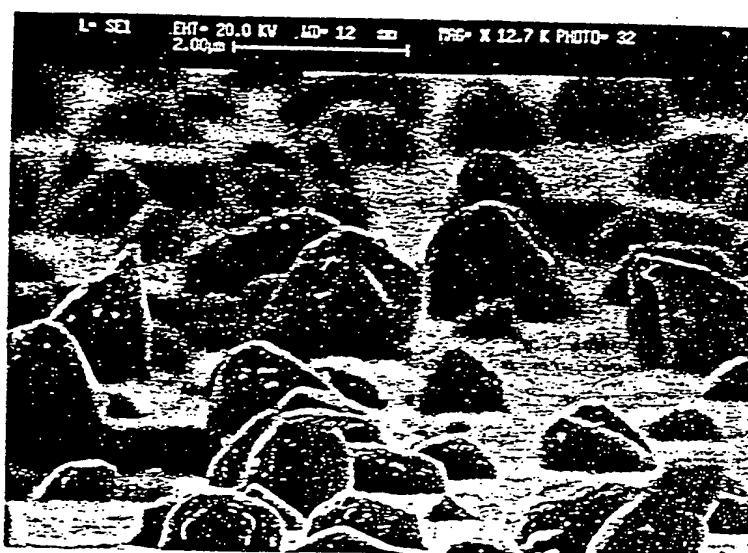
shape. Although they appear roughly circular under high power microscopy (400X), they are actually polyhedral and exhibit a wide range of aspect ratios (Figure 3). Typical height/width ratios range from 0.3 to 1.8.

Figure 3: Silicon precipitates (nodules) viewed from side exhibit variety of shapes and sizes. (12700X)

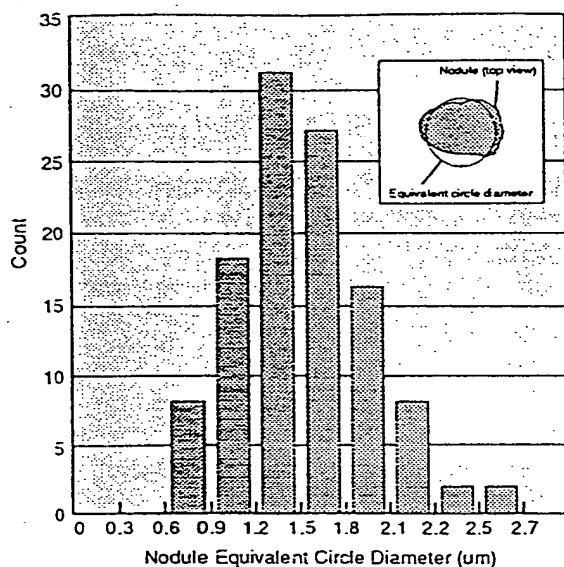
There were typically 50×10^3 to 100×10^3 nodules per square millimeter in the subject devices. In general, the nodule density -- the number of nodules per unit surface area -- was inversely proportionate to the average size of the nodules. That is, when the nodules were large, there tended to be few of them. Conversely, when the nodule count was high, they tended to be small. Figure 4 shows a typical histogram of nodule sizes produced by an image analysis

Figure 4: Example distribution of nodule sizes

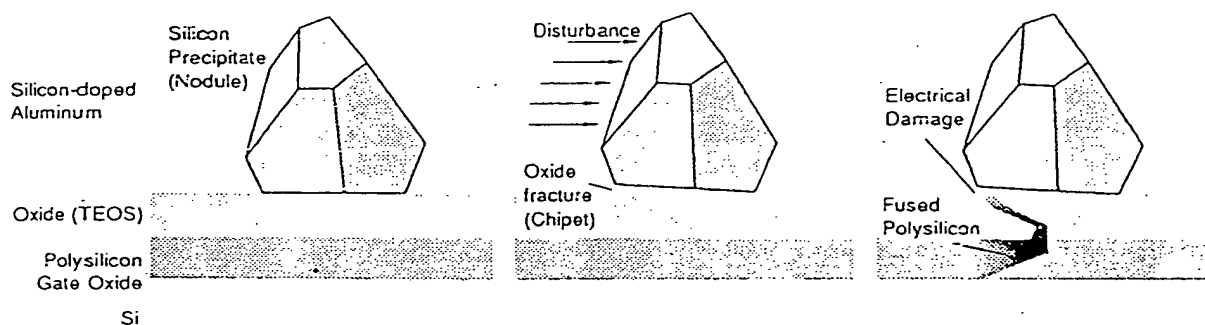
The adhered nodules could be removed quite easily; gentle brushing of a few fibers from a cotton swab was sufficient to disturb them. When these well-adhered nodules are displaced, they often take with them a portion of underlying oxide, forming a distinctive, football-shaped chip-out, or *chipet* (Figure 5). The depth of the resulting chipet was roughly equal to half the length of the chipet's minor axis, itself related to the area of contact between nodule and oxide.

In the MOSFET devices the lateral displacement of the nodules occurs during the wirebonding process. The cavity formed by the chipet is immediately filled with aluminum. These chipets, during

Figure 5: Movement of nodule results in fracture of underlying oxide.

electrical stress, appear to act as weak points in the insulating oxide. If the chiplet is sufficiently deep to fully compromise the thickness of the dielectric oxide, a linear resistive short between the source metallization and gate polysilicon results. However, if the root only partially compromises the dielectric, a leaky diode-like characteristic results.
